**BAXTER LAKE EASTERLY DIKE
NH 00391**

**PHASE I INSPECTION REPORT
NATIONAL DAM INSPECTION PROGRAM**

JULY 1978

PISCATAQUA RIVER BASIN
ROCHESTER, NEW HAMPSHIRE

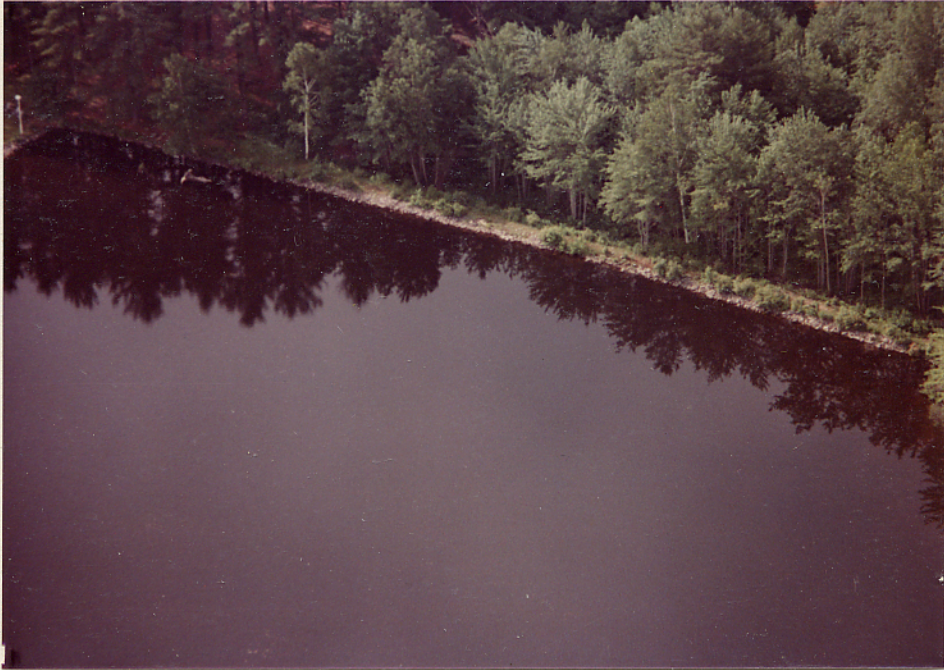
Figure 1 - Overview of the upstream face of the dike.

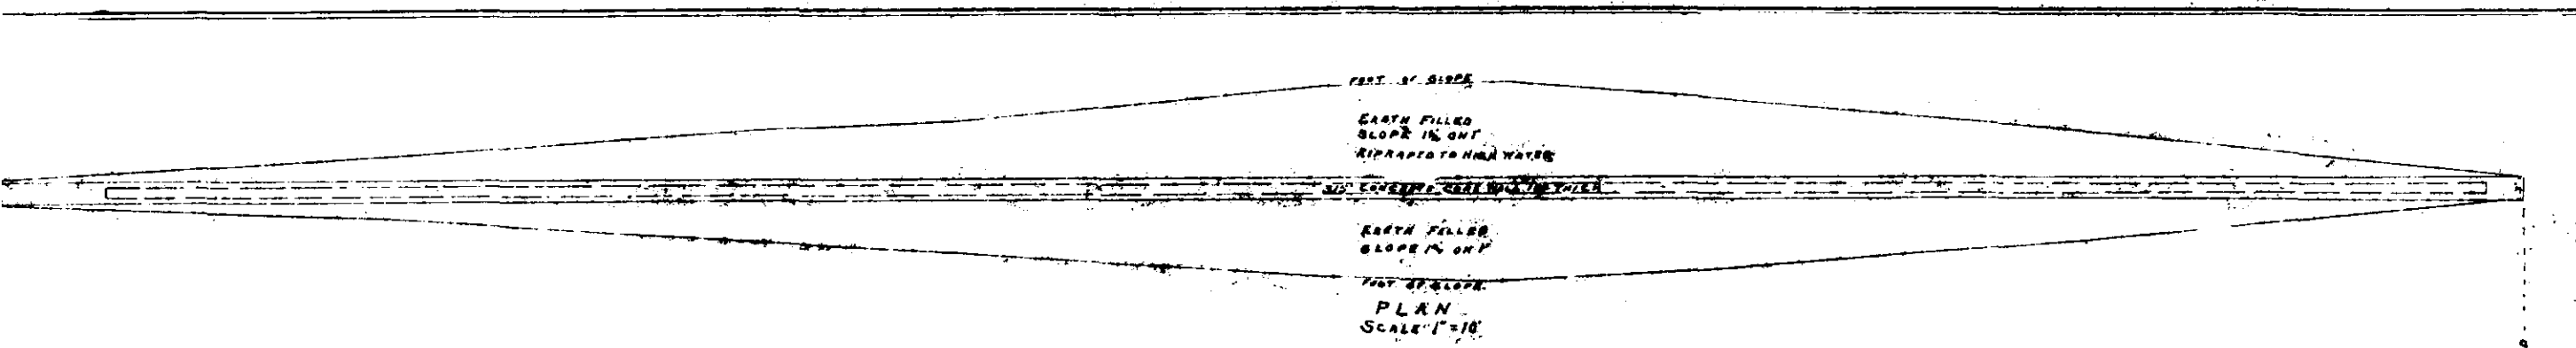
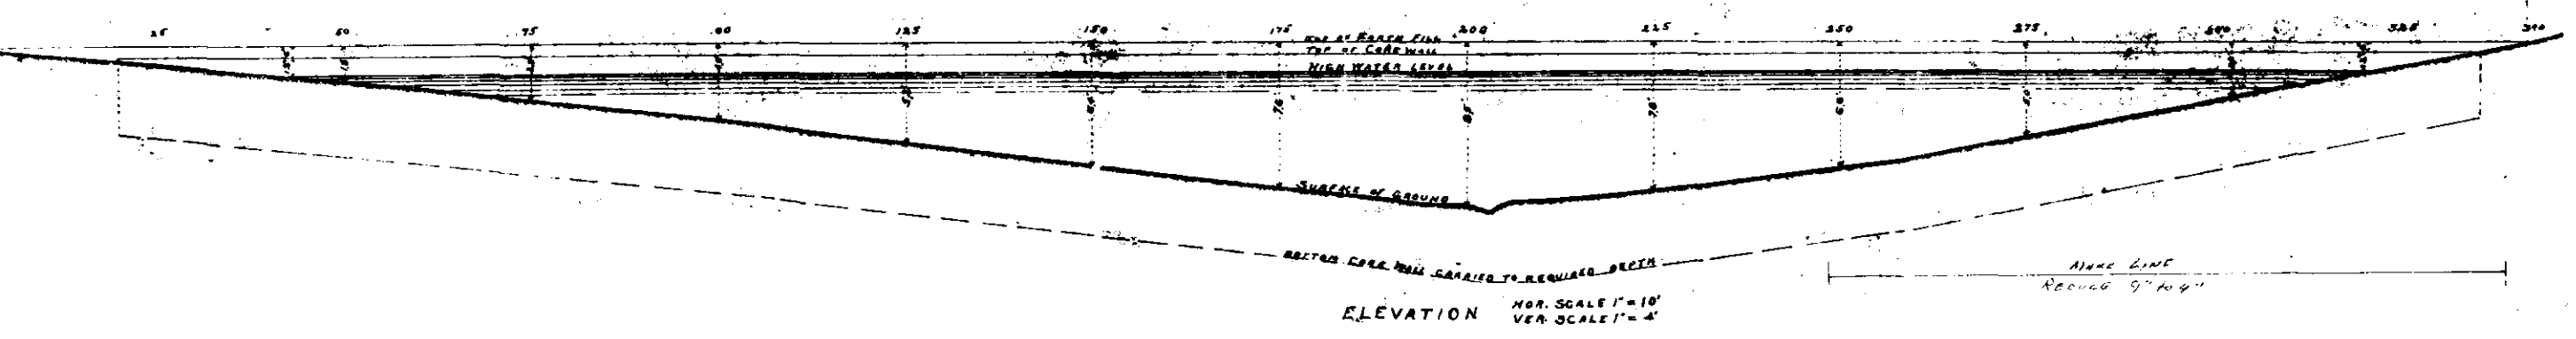
DAM NUMBER THREE

The visual inspection did not reveal any evidence of the concrete core wall noted on the plan labeled "Dam Number Three" as drawn by L. E. Scruton, C. E. (See Appendix B.)

b. Design and Construction Data. An available design drawing, labeled "Dam Number Three", indicates the presence of a concrete core wall along the center of the dike. However, no information is available about the as-constructed dimensions or conditions within the dike, the foundation or the character of the earthfill used in constructing the dike.

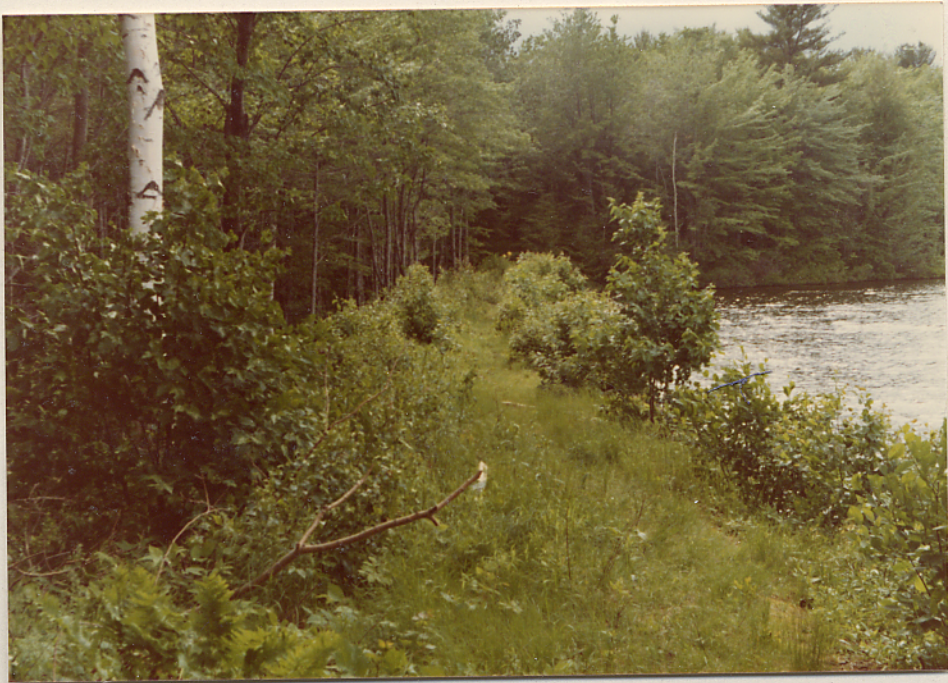
There is some trespassing, and a footpath has been worn bare on the crest of the dike. Because of the small freeboard, erosion is a particularly serious potential problem and trespassing must be controlled so as not to initiate erosion.

Figure 2 - Looking northwest across the top of the dike.

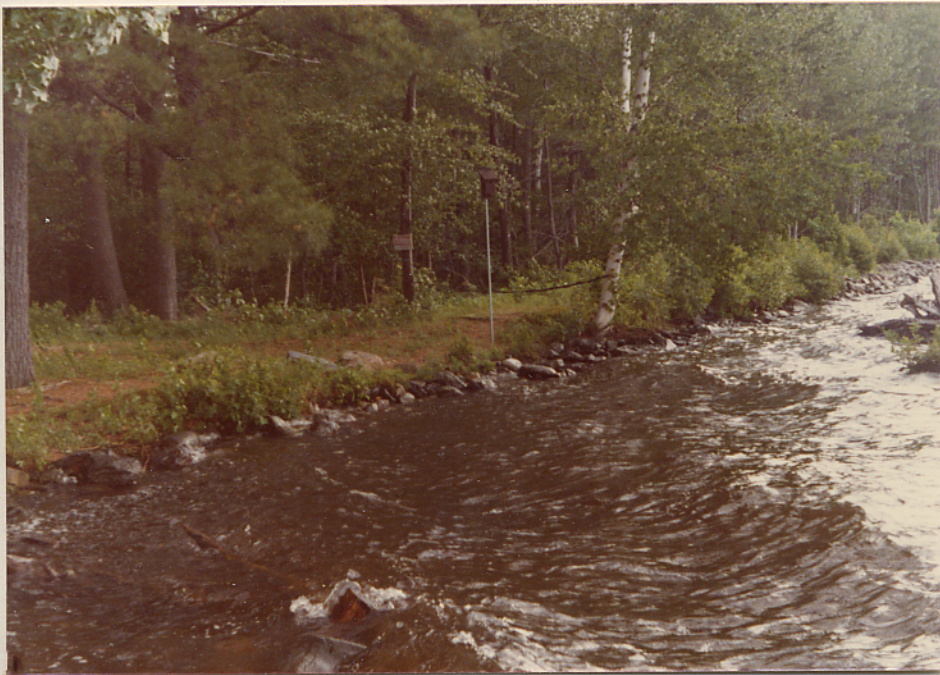
crest varies from 1 foot to 2 feet above the stoplog spillway. Trespassing has worn the crest bare in places and poses a potential erosion problem. The dike is also subject to heavy winds and waves which have raveled the upstream face. No evidence of damage from prior overtoppings was visible at the time of inspection.

Figure 3 - Looking at the upstream face and southeast abutment. The low point beyond the abutment is at the center of the photo. Note wave action.

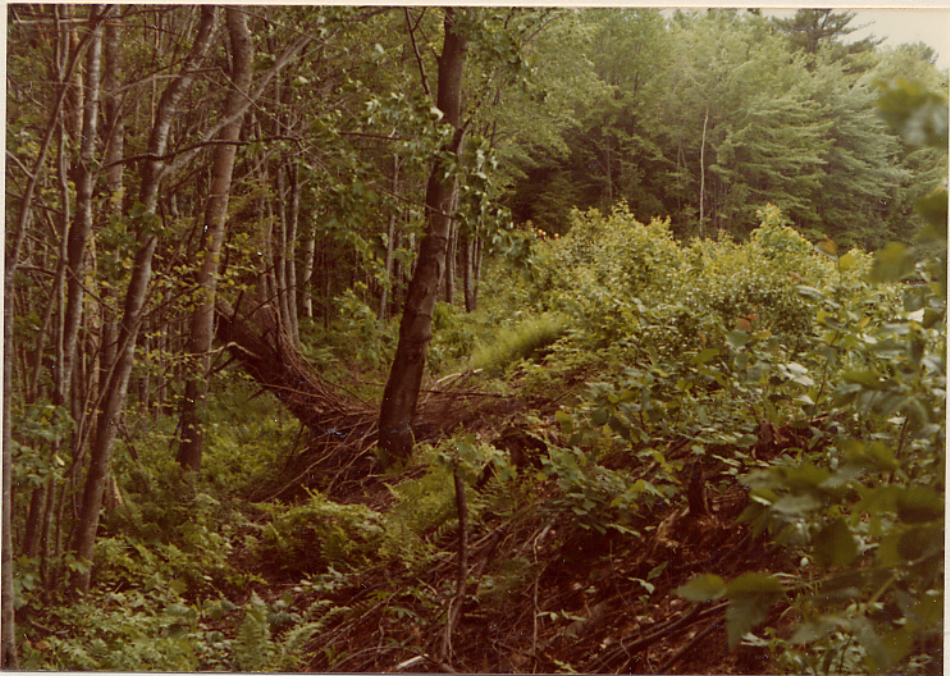
Trees and brush are growing on both the upstream and downstream faces of the dike, and could pose a long-term problem when the trees die and the roots rot. Some tree stumps located on the dike are beginning to rot.

Figure 4 - Looking northwest across the downstream face of the dike.

(1) The trees and brush should not be cleared from the dike until the recommended measures for increasing the freeboard and controlling the seepage at the downstream toe of the dike are implemented. The reason for this is that the roots of the trees and brush will provide some resistance against erosion if the dike should be overtopped again.

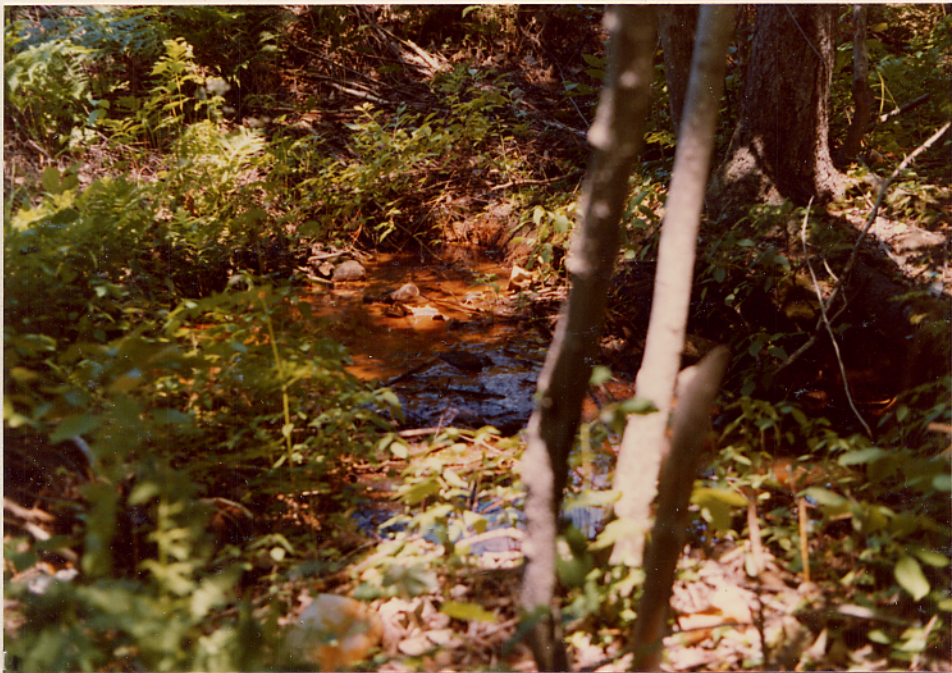
Extensive seepage was observed along the entire length of the dike, with higher concentrations at the easterly end. (Estimated discharge 0.04 cfs) (See Appendix C - Figure 5.) The crest of the dike has a path about 3 feet wide that has been worn bare by foot traffic. Several tree roots, transverse to the axis of the dike, are exposed at the surface in the footpath. Trees are growing immediately downstream of the downstream toe of the dike. Numerous trees on the downstream face have been cut, leaving tree stumps ranging up to 8 inches in diameter.

- (1) extensive seepage at the downstream toe of the dike;
- (2) very small freeboard at the east end, combined with inadequate spillway capacity at the Main Dam on Baxter Lake and the historical record that the dike has been overtopped, breached, and rebuilt;
- (3) trees and brush growing on the upstream and downstream slopes of the dike.

Figure 5 - Seepage at downstream toe of dike near southeast end.

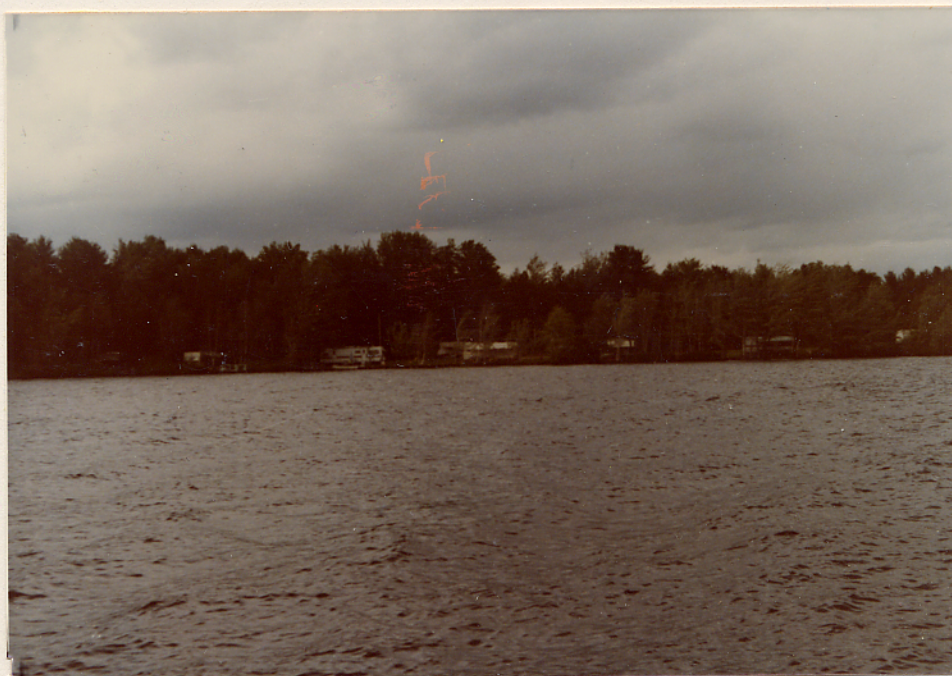
Figure 6 - Looking upstream at the reservoir
from the center of the dike.
